Tanja Ratilainen

AT THE DAWN OF MASONRY ARCHITECTURE – CHURCH REMAINS AND ASSOCIATED BRICK STRUCTURES AT KOROINEN, TURKU

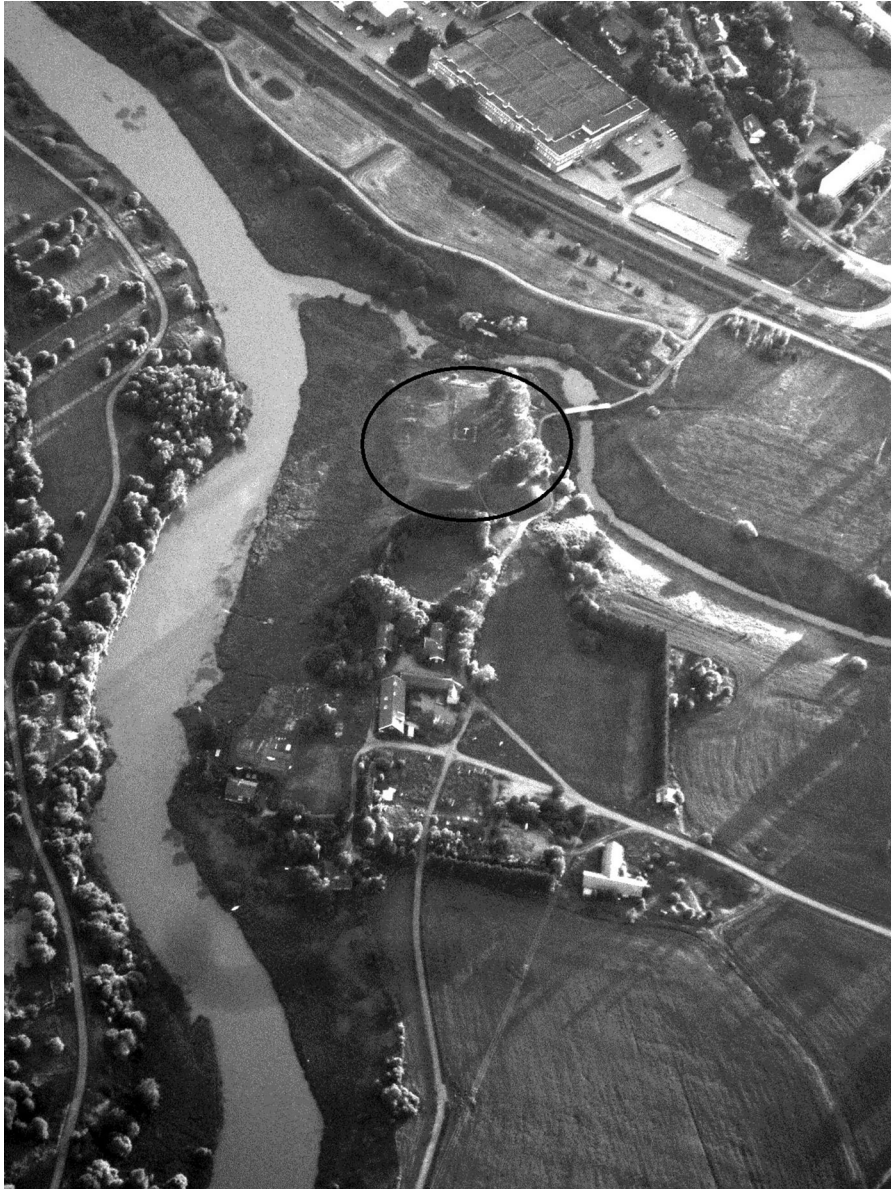
Fig. 2. The site (circled) in the branch of the Rivers Aurajoki (left) and Vähäjoki (right) from the east. Photo by Auli Bläuer (1.8.2012).

The first cathedral of the Diocese of Finland was located probably in Nousiainen, ca 20 km northwest of Turku (Fig. 1). Sometime after 1229 the episcopal see was transferred to Koroinen, a cape formed by the joining Rivers Aurajoki and Vähäjoki (Fig. 2). Kirsi Salonen (2014, 16) has recently suggested that since the Bishop of Finland was active in Nousiainen at the beginning of the 1230s (1232, 1234), the transfer of the see to Koroinen did not happen right away after 1229. Finally, the see was relocated to the town of Turku, 1.6 km downstream from Koroinen. The town was founded around 1300 (FMU 72; Gallén 1978, 321; Gardberg 2000, 22, 27; Hiekkänen 2007, 184, 188, on the church history of Finland, see Heininen & Heikkilä 2002).

At present, the Cape of Koroinen is separated from the mainland by a small man-made dry moat and an embankment. In the middle of the area of approximately 65 x 85 metres there are three E-W oriented lines of stones forming a rectangular foundation with some N-S oriented stones. At the east end of these structures there is a square masonry foundation without a west wall. In addition, there are remains of two masonry buildings by the southern river bank and a lesser brick structure in between them (Figs 2–3).

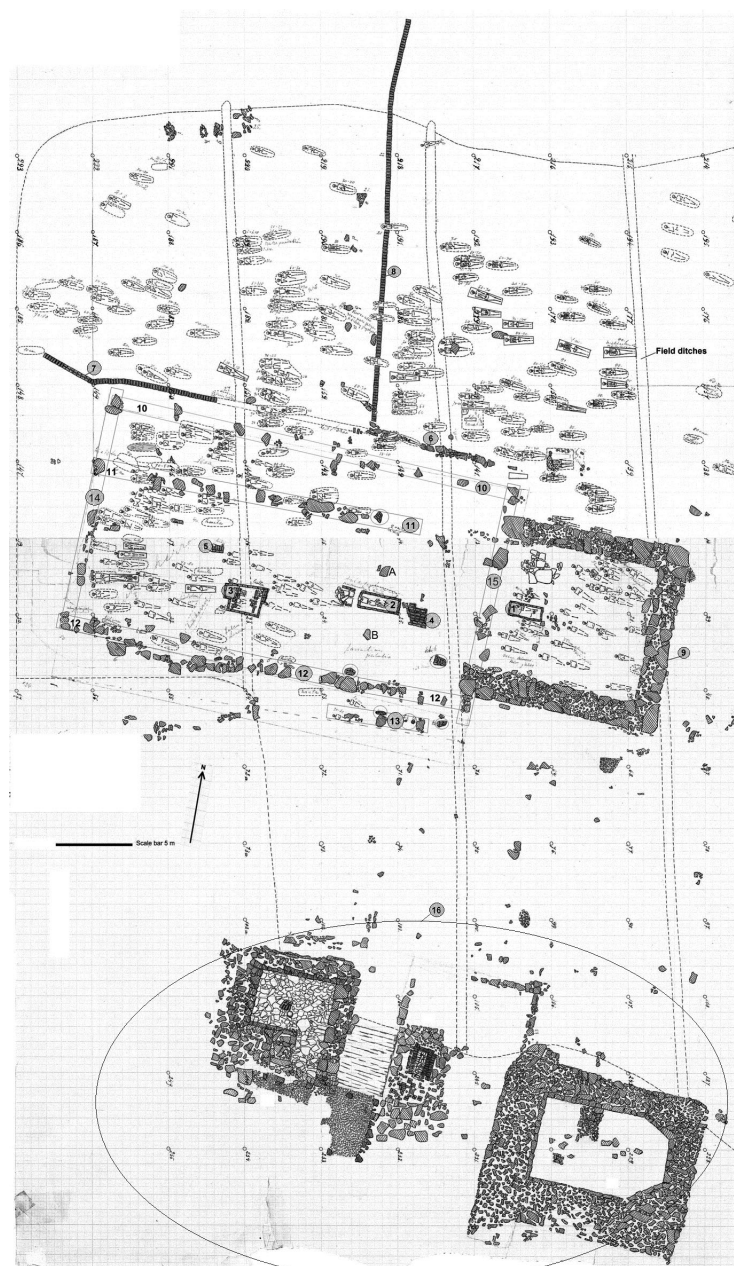
Fig. 3. Locations of the structures at Koroinen. 1–3 Brick-walled grave, 4 altar foundation, 5 foundation for a baptismal font, 6–8 subsurface drain, 9 foundation of a masonry building, 10–12 stone foundations of wooden naves, 13 line of stones, function open, 14–15 stone foundations of wooden naves, A, B possible corner stones of a narrow choir. The remains of masonry houses and other structures south of the church by the river bank were excluded from the material (16). The radiocarbon-dated grave is marked with a grey oval area near the west end of structure 10. The brick waste (circled) discovered mostly at the east end of the church could be the crushed remains of the altar (4) and its foundation spread by ploughing. Scale bar 5 metres. Map: Juhani Rinne, modified by Tanja Ratilainen.

In the centre of the site, Rinne found mostly E-W and N-S oriented lines of stones, which according to him formed a rectangular nave measuring 27.5 m × 10.5 m without a narrow choir (Fig. 3, structures 11, 12, 14, 15). He interpreted the structure as the first wooden church of the site, which would have

burnt down, then being repaired and extended 4 metres to the north (Fig. 3, structure 10), after which it was converted into a three-aisled basilica. The six metre-long line of stones at the south side of the nave served as a cross-aisle gallery (Fig. 3, structure 13), originally much longer and with one grave showing, among other features, the influence of the Dominicans on the architecture. The brick structure in the eastern part of the nave was the remains of a brick floor (Rinne's notes 1900–1902; Rinne 1941, 44 ff.) (Fig. 3, structure 4).

The masonry structure at the east end of the church was a foundation for a choir-tower (Fig. 3, structure 9), which was built last onto the enlarged wooden church. Based e.g. on the brick size and coin finds, Rinne deduced that the use of the site already began at the end of the 12th century. The masonry building was erected sometime in 1266–1286 since the last of the three bishops buried at Koroinen, Bishop Catillus was buried there in 1286 in a brick-walled grave (Rinne 1941, 51 ff.) (Fig. 3, structure 1). After the see was moved to Turku, the church served as a parish church until the end of the 14th century (Rinne 1941, 57).

The remains of a masonry building (9) located on the east side of all the structures in the level area measured 12.5 × 12 m × 1.50–2.0 m (Fig. 3). Rinne (1941, 54 f.) suggested it was a foundation for a choir-tower of stone. In the notes (1902) he stated that there was no brick waste at all in the area of the structure, but later (1941, 53) interpreted that the brick waste found by the river bank above the eastern masonry building was transferred or had slid down from structure 9 and therefore the building probably had a triumphal arch and vaulting and windows made of bricks.

The width of the nave, however, can be again questioned, since there was a five-metre-long line of E-W-oriented stones (structure 13) found ca 2 metres apart from structure 12 (see Fig. 3). Instead of a cross-aisled gallery, could these stones indicate the location of the south wall of the second wooden nave? In that way the masonry building would have been more symmetrically positioned in relation to the wooden nave. There are, however, so few stones left that it seems an exaggeration to interpret the south wall of the second church as having been located there. In addition, one would expect more graves to be found in the area, if it had been inside the nave. Most importantly, the foundation of the baptismal font is located in the middle axis of structures 10 and 12, which were most likely the walls of the second nave. Therefore, it seems likely that the second nave was 14.5 metres in width, and the purpose of the stones on the south side must be left open for the time being.

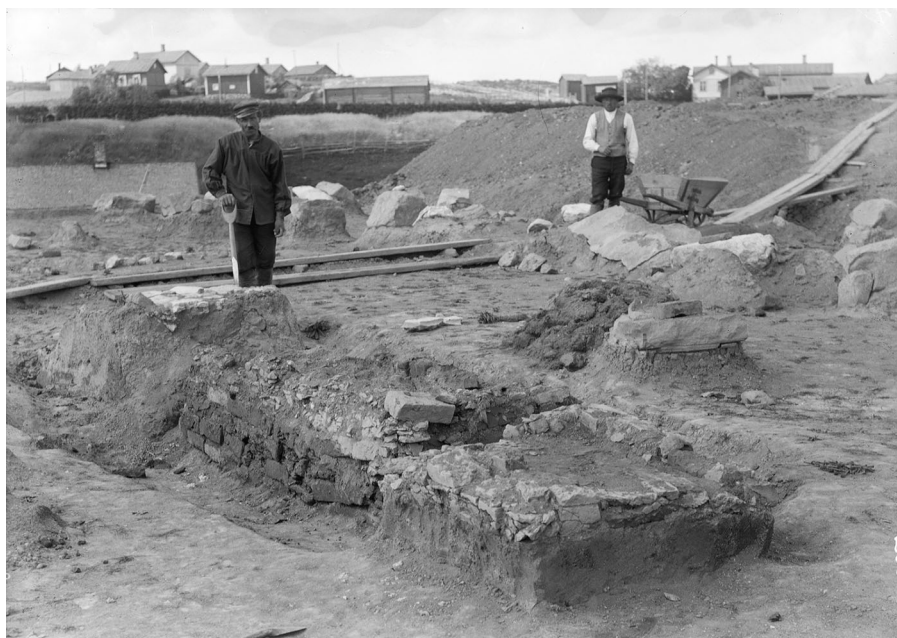
Fig. 4. Altar foundation (structure 4) in front. Brick-walled grave 2 in between the altar and a grave covered with limestone in the back, which located 10 cm higher than the brick-walled grave 2. Photo by Julius Ailio / Archives of the National Board of Antiquities.

120 × 80 × 30 cm, then the length seems unlikely. The size of the discovered brick foundation could after all be original. Probably the whole altar foundation was entirely made of bricks. The remains of bricks recorded in the map (Fig. 3) mostly in the east end of the church could be crushed remains of the altar and its foundation spread by ploughing.

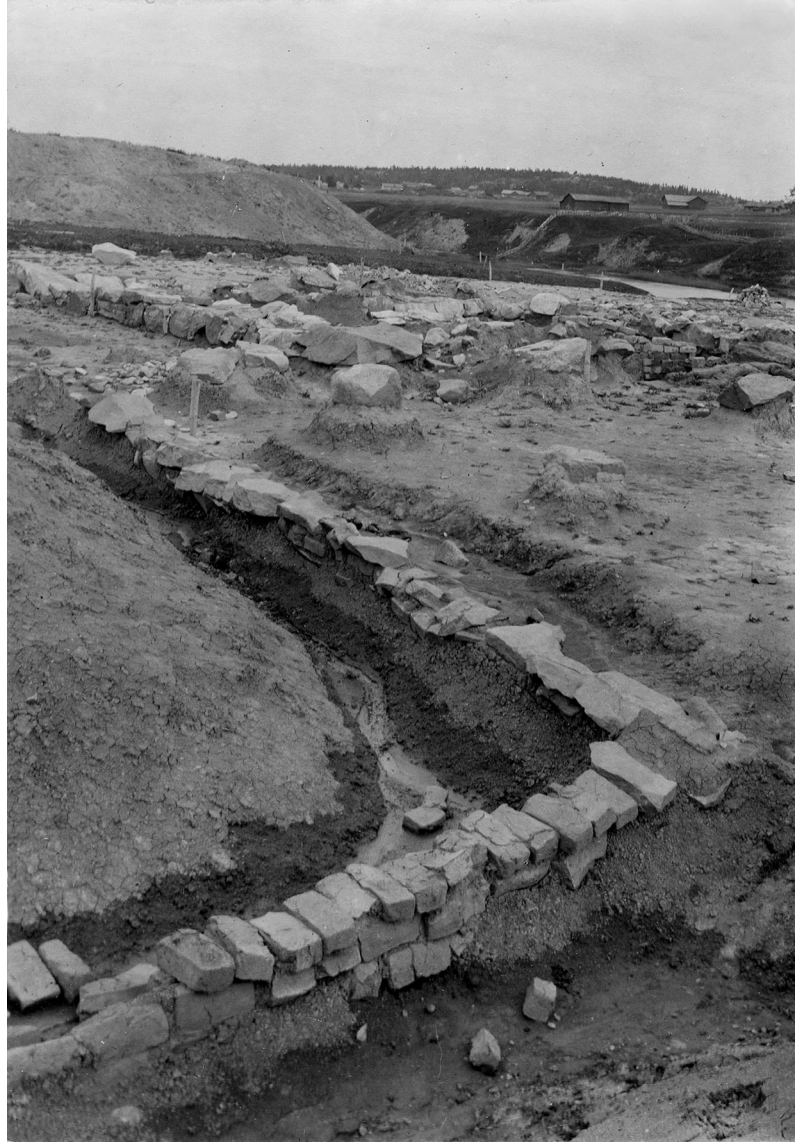
Fig. 5. Structures 6 and 8 seen from the NW. Photo: Val137-16, Ailio / Photo Archives of the Museum Centre of Turku.

On the north side of the church remains Rinne found two E-W oriented structures of which the western one was laid of bricks (7), and the eastern one was laid of stones (6) and to which a N-S oriented brick structure was connected (8) (see Fig. 3). At first Rinne (notes 1901) called the brick structures a fence, but later he concluded that it must have been a subsurface drain for leading water away from the church (Rinne 1941, 49 f.). Harjapää (1996, 58) suggested that structure 6 was a stone foundation for a wooden wall structure protecting the stave church from water, while the remaining structures 7 and 8 functioned as a drain.

In brick structure 7 there were mostly 3 layers of bricks. In the first one bricks were put on their side and lengthways. On top of them bricks were put on their flat side and lengthways, and on top of these the third layer was put on their flat side and across the structure. In that way a structure 25–27 cm wide and 33–39 cm high was created.⁷ Structure 7 was described as being 40–45 cm deeper in the ground than the line of stones (structure 10) constituting the north wall of the enlarged nave. In structure 8, the bricks were partly laid differently and there were also some stones in between, but they also formed a channel. Structures 7 and 8 clearly sloped from the east to west towards the Rive Aurajoki and from south to north towards the River Vähäjoki. No remains of mortar were found between the stones. Rinne (notes 1901) does not describe the structure 6 in his notes, but only mentioned that it was aligned with the structure 7. Later he (1941, 50) described it as built of grey stones put on their sides above which stone slabs were laid. In the photograph the structure looks like Rinne described it (see Fig. 5).

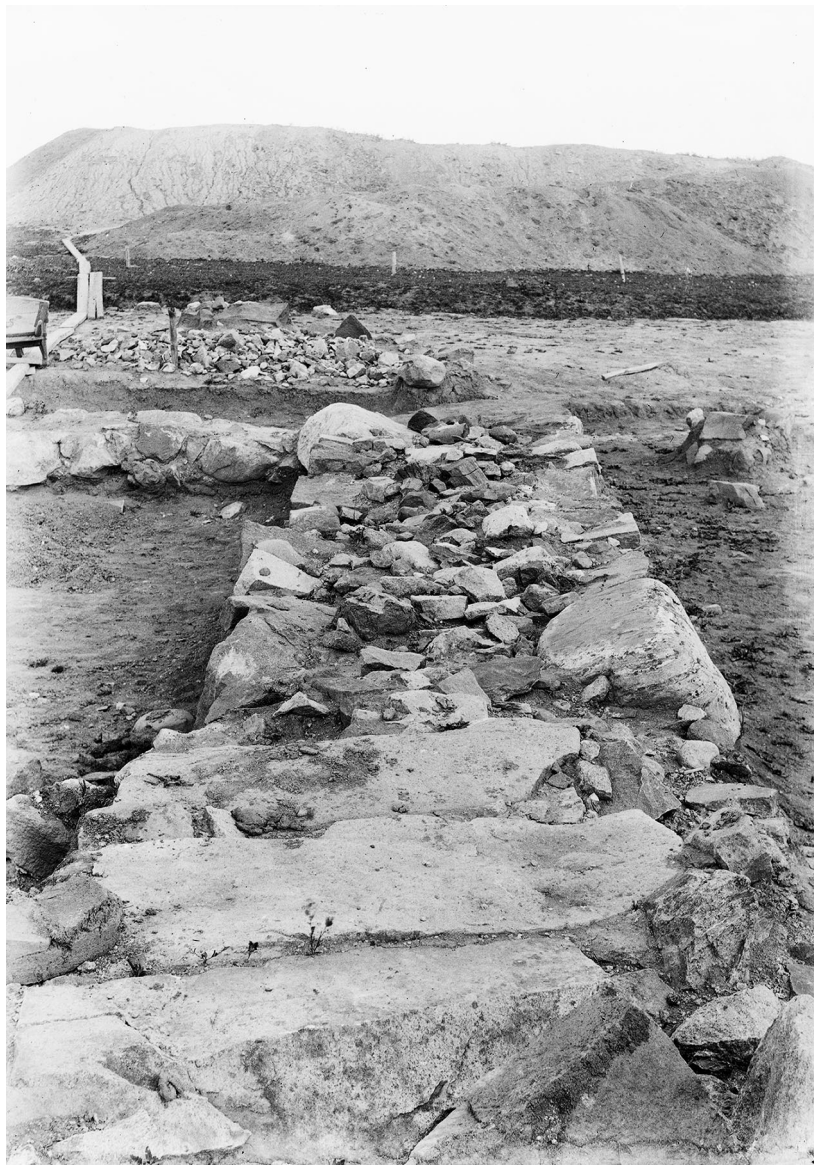
Fig. 6. Structure 9, the southern foundations of the masonry building seen from the west. Photo by Julius Ailio / Archives of the National Board of Antiquities.

with lime and concluded they were meant to be underground (see Fig. 6). Under the stones Rinne recorded a 5–6 cm thick layer of sand overlaying natural clay. He found no evidence of wooden foundations under the stones (Rinne, notes 1902). In addition, Rinne argued that originally the building remains had a western foundation, but they had been more severely destroyed than the other remains.

Based on the photographs, the stones were partly shaped and, interestingly, laid in a way as if they were meant to be seen. The flat surface of the stone was laid as the interior and exterior surface of the ‘shell wall’, even in the first layer of the foundations, which must have been underground. It is difficult to discern from the black and white photographs if there are remains of lime mortar between the stones, but it looks like there is mostly earth. There may be traces of lime on some upper or side surfaces (see Figs 6–7).

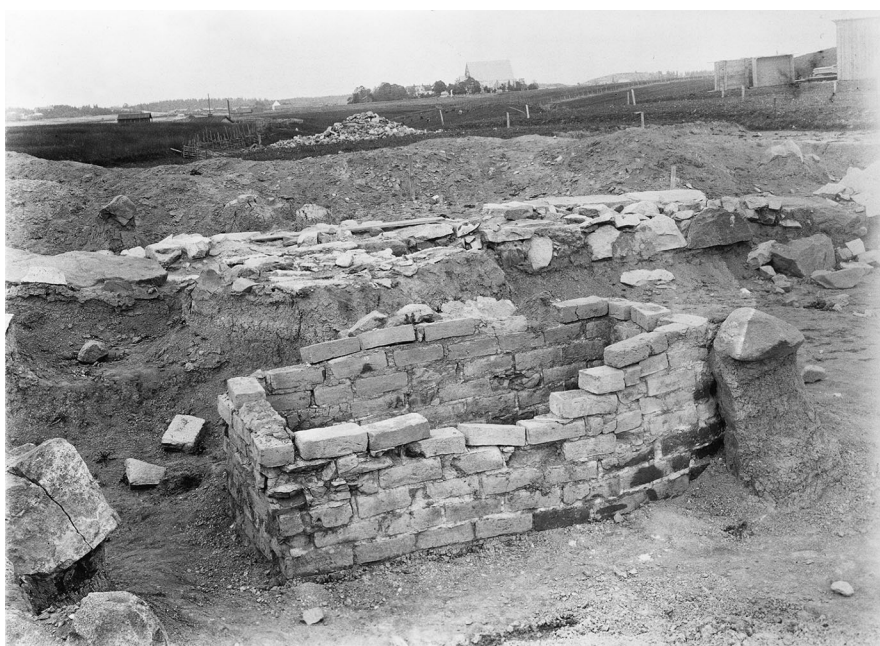
Fig. 7. Brick-walled grave 1 and the grave covered with a limestone slab on its north side in the masonry building (9). Note the level of the foundations in relation to the graves. Photo by Julius Ailio / Archives of the National Board of Antiquities.
