Ain Lavi

## AN ADDENDUM TO THE STUDY OF SMOKE COTTAGES

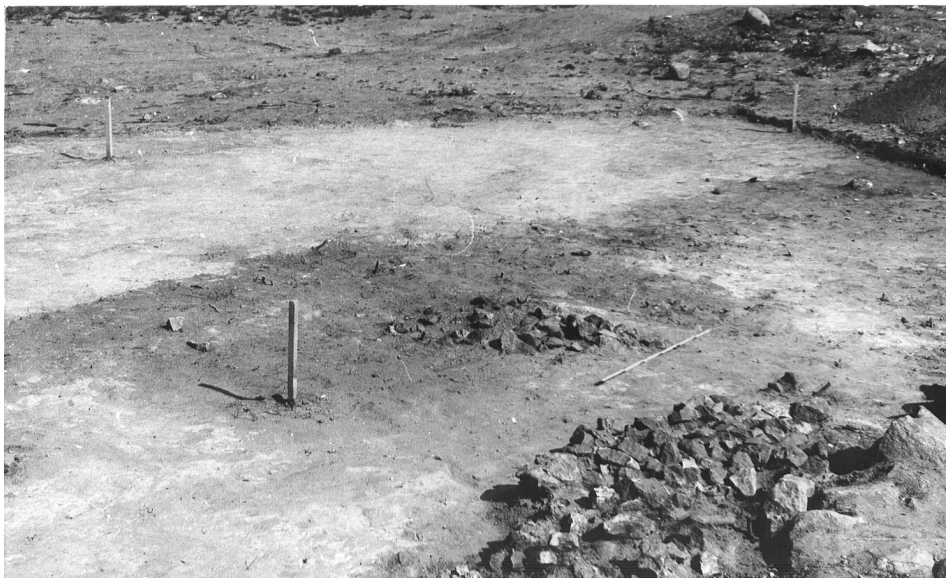
**Fig. 1.** Olustvere settlement, hearth No. 24. The darker patch of a probable house sill can be discerned on the sandy ground surrounding the hearth. The remains of the earthen stove No. 23 can be seen in the forefront. The view is from the NW side.

A darker patch (3.5–4 m in diameter) could be discerned in the sandy ground surrounding the hearth; this could be indicative of a one-time house sill (Fig. 1). The most suitable place for an open hearth was in the middle of a dwelling.

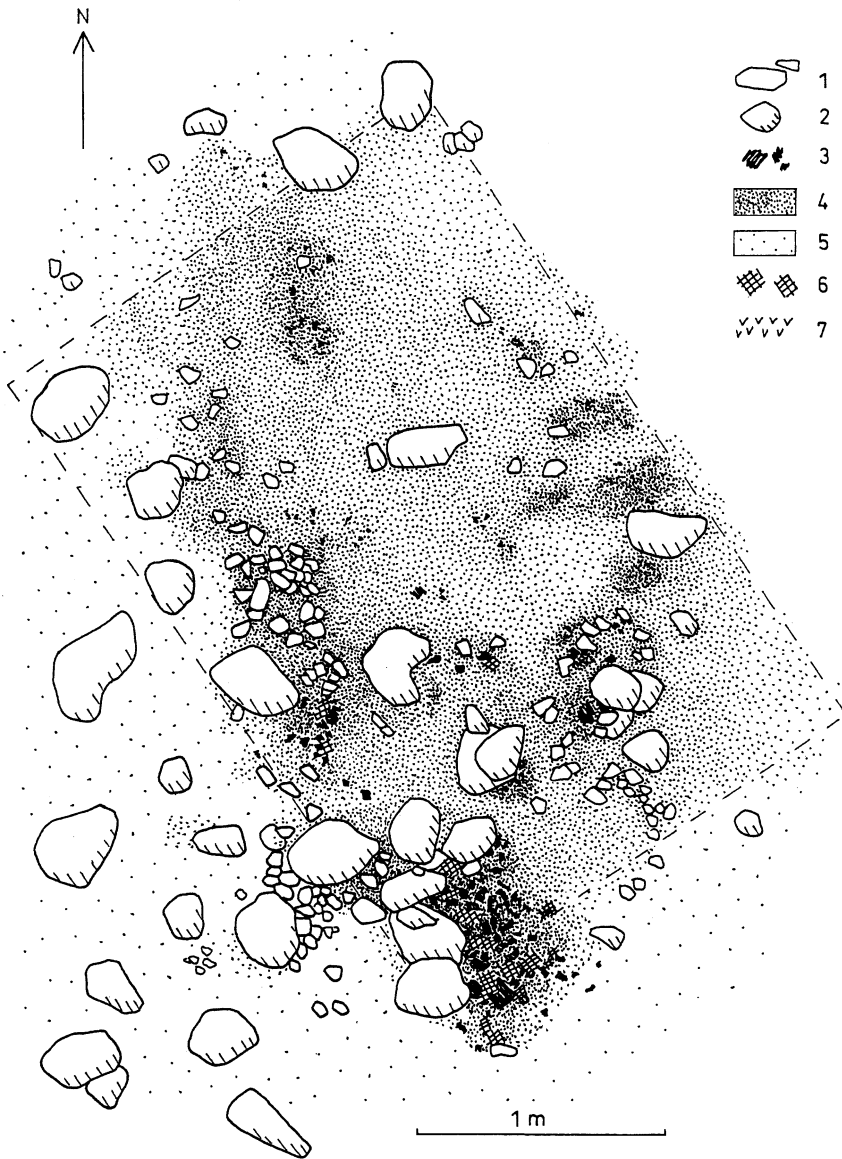
**Fig. 2.** Olustvere settlement, excavation VII. Plan of a house sill (O. VII, 2). 1 limestone, 2 granite stones, 3 charcoal remains, 4 charcoal-stained soil, 5 sand, 6 heat-treated clay, 7 rubble.

**Olustvere Excavation VII, Dwelling site No. 2** (in further text: O. VII, 2) was discovered on a West–East oriented slope. The length of the NW–SE oriented house sill was 5.7 m, the width was 4 m (Fig. 2). To achieve even flooring, the higher western side of the building had been dug into the ground to the depth of about 20 cm. Consequently, the outlines of the dredged construction part were visible more clearly. The dug-in logs of the south-western wall had been resting on granite rocks that were 30–50 cm in diameter and lay in tandem; some stones were also recovered from under the NW wall outline.

In the southeastern corner of the building, the remains of an open rock stove were found, consisting of a jumbled heap (1.7 m in diameter) of granite rocks of different sizes, that had been subject to heat disintegration. In the course of cleaning out the stove location, an abundance of earthen fragments and jointings were unearthed. The scattered firebrand remnants found from all over the house sill may originate from the upper layers of the building – the caved-in roof or the ceiling.

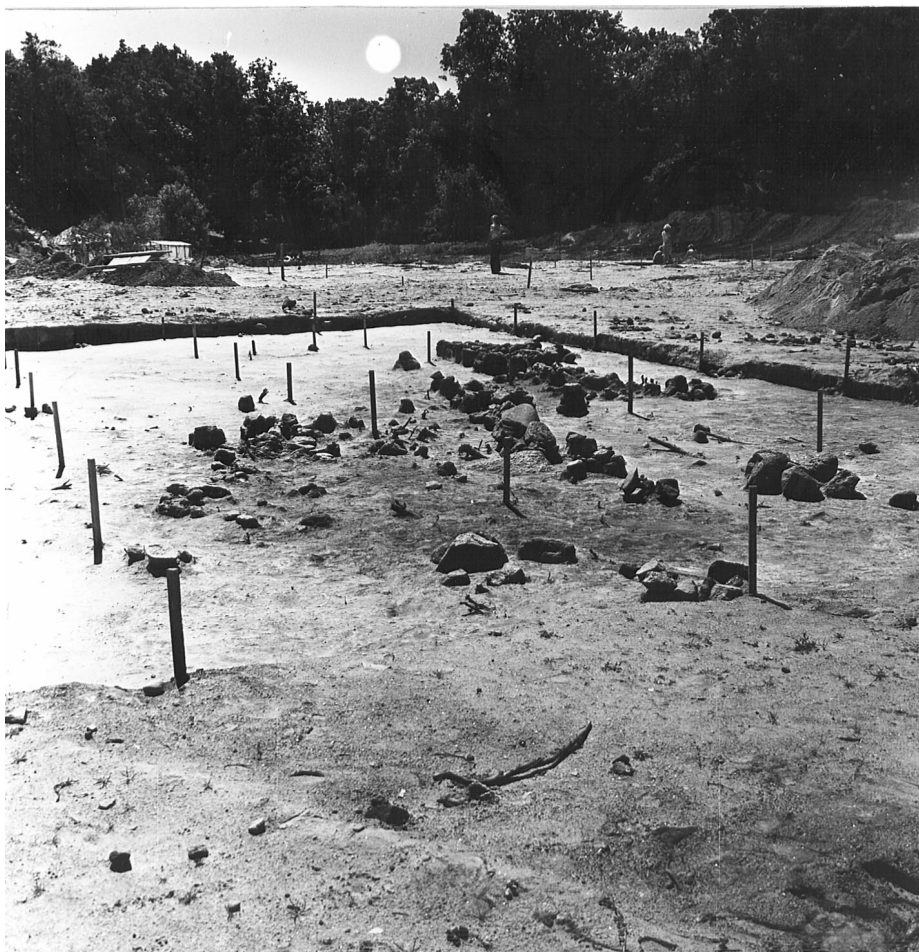
**Fig. 3.** Olustvere settlement, excavation I. The northeastern, darker patch of the house sill can be discerned in the sandy ground (O. I, 1). The view is from the NNE side.

**House site O. I, 1** belonged to the late Iron Age. The sill stood out on sandy soil as a dark, sooty, at places distinctly detectable rectangular patch (6 × 4.5 m), with its long axis oriented NE–SW (Fig. 3). As the NE end had been dug into the sandy earth the contour of the one-time house sill was visible more clearly on that side. The nearby post-hole containing rubble could be associated with some adjoining construction – e.g. an entrance hall – that rested on a post-frame.

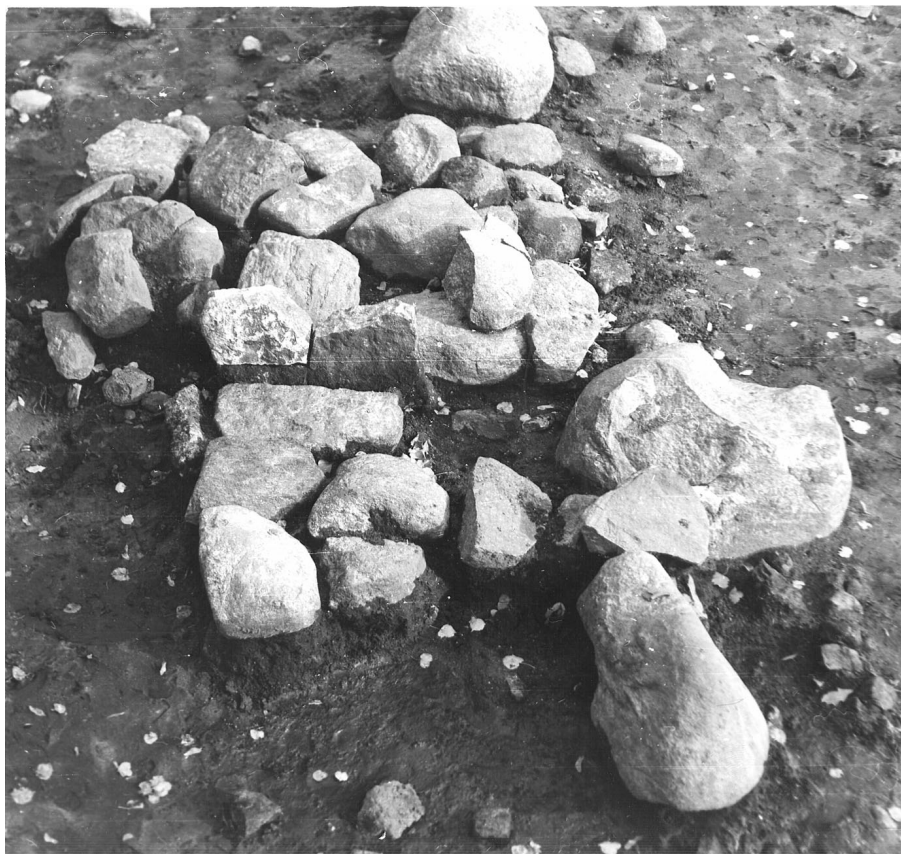
**Fig. 5.** Olustvere settlement. Remains of an open rock stove in a house site (O. IV, 1). The view is from the western side.

located in the north-eastern corner of the building, with its mouth facing westward. The traces of a 60 × 80 cm furnace had been preserved at the stove-mouth, consisting of evenly laid granite stones (Fig. 5) that had an average diameter of 30–35 cm and were covered by a 10 cm thick layer of charcoal. The back of the furnace was made of a limestone slab positioned edgewise (measures 30 × 50 cm; thickness 11 cm), which seems to have been originally supported by a wall of granite rocks that measured 30 to 50 cm in diameter. Some of the granite stones from the sidewalls of the stove have also been preserved. An ash-pit may have been situated at the stove-mouth, but the outlines cannot really be recognized in the highly charcoal-stained layer. In the area around the stove, fragments of home-made bricks were found from among the stove rocks. The  $^{14}\text{C}$  analyses (Tln-459) of the building remains gave the date  $550 \pm 50$  BP, with the calibrated date ranging from AD 1310–1350; 1380–1430 (1 sigma), 1290–1410 (2 sigma).

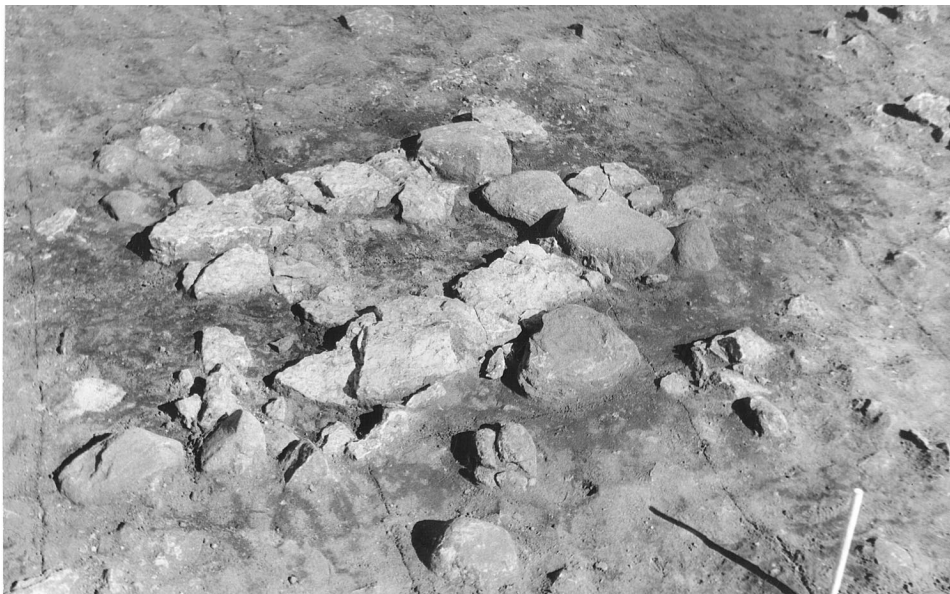
**Fig. 6.** Lehmja settlement. Remains of a stove in a house sill (L. 3). The side walls of the stove have been laid of limestone slabs, the base under the back wall of the hearth has been built of granite. The view is from the NW side.

The long axis of the open rock stove had been oriented NNW–SSE, with the stove standing in the SW corner of the chamber and its opening facing NNW (Fig. 6). The general dimensions of the stove were 1.5 × 1.3–1.4 m and its eastern and western side walls (40 cm wide on average) had been laid of large limestone slabs with an average thickness of 10 cm (38 × 80, 37 × 90 cm). In contrast, the stove base that had been preserved at the back wall of the stove remains had been laid of three layers of flat-topped granite rocks (diameter 35–45 cm) that may also have carried some extra wall-stones from upper layers. The base of another limestone wall was discovered from behind the stove wall. The length of the furnace ranged up to 95 cm, the width was 50–60 cm; the hearthstone represented a

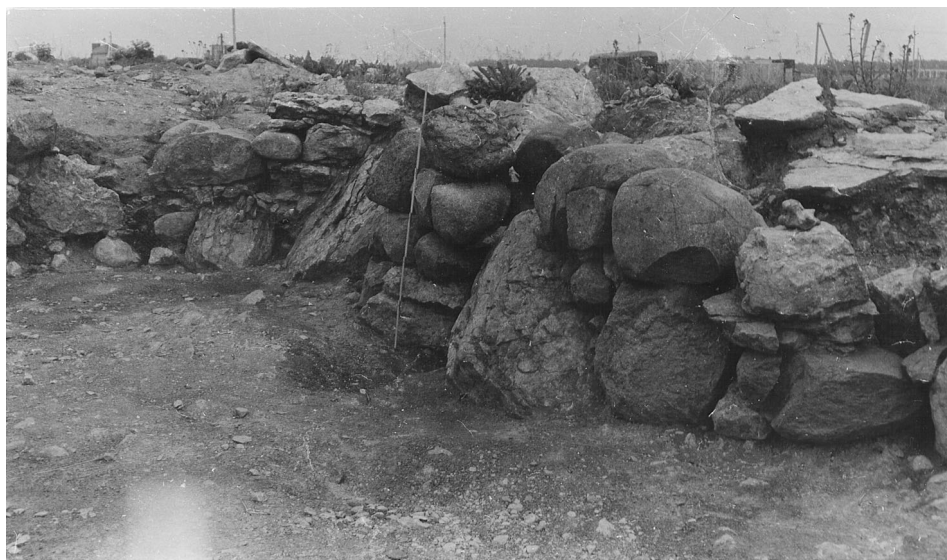
**Fig. 7.** Lehmja settlement, house sill (L. 12). The dug-in wall of the pit-house consists of granite stones and natural limestone boulders. The view is from the NW side.

The remains of a pit house **L. 12** (inside dimensions 4.5–3.5 m) had been dug 1 m deep into natural sand, with its long axis oriented WNW–ESE. The walls of the dug-in part had been dry-laid by fitting together quarry stones and limestone slabs; also the locally common huge natural flagstone slabs had been used (Fig. 7). The entrance to the building was located in the middle of the western wall, being

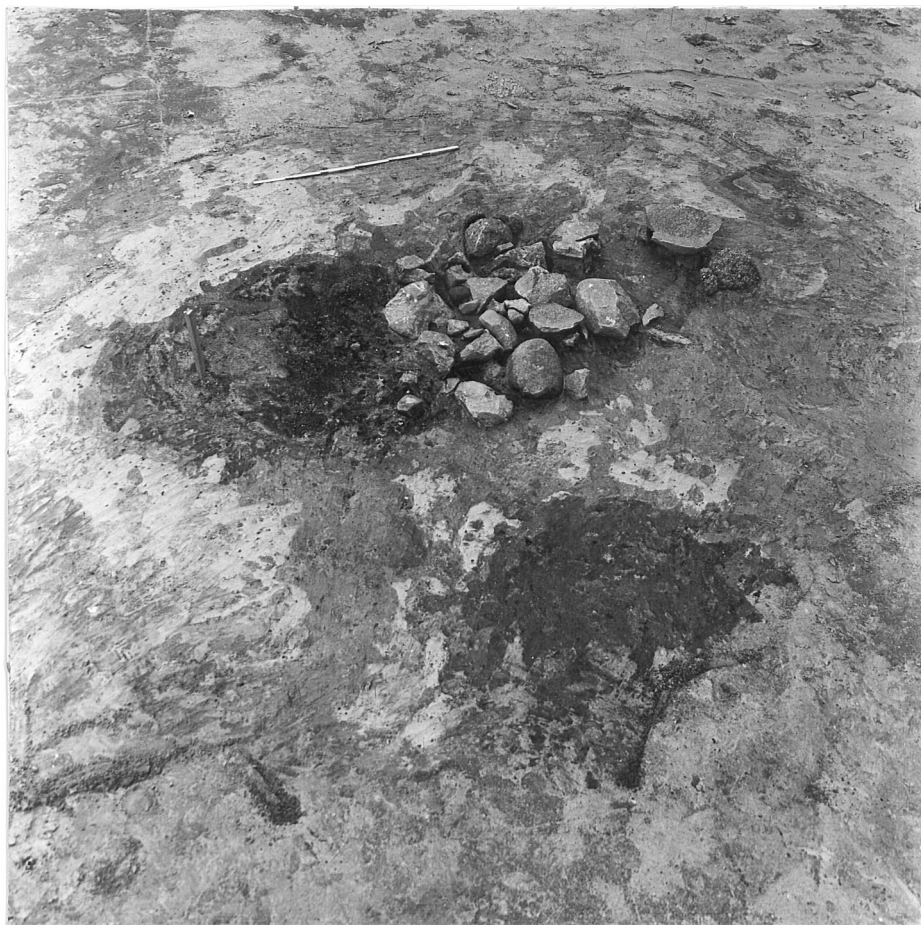
**Fig. 8.** Olustvere settlement, remains of Stove No. 27. On the right, there is a stone heap that has remained from the open rock stove; the remains are adjoined by a dark spot denoting the position of the ash-pit.

Only a heap (1 m in diameter) of heat-affected granite stones that were 18 to 40 cm in diameter had survived the bulldozer working on the site of **O. III Furnace No. 27**. A pot-shaped depression – the ash-pit (Fig. 8) – was located in the immediate vicinity of the eastern side of the heap; the pit had filled up with 2–7 cm thick, charcoal- and ash-coloured, overlapping streaks. In cleaning out of the ash-pit, fragments of early medieval pottery were found.

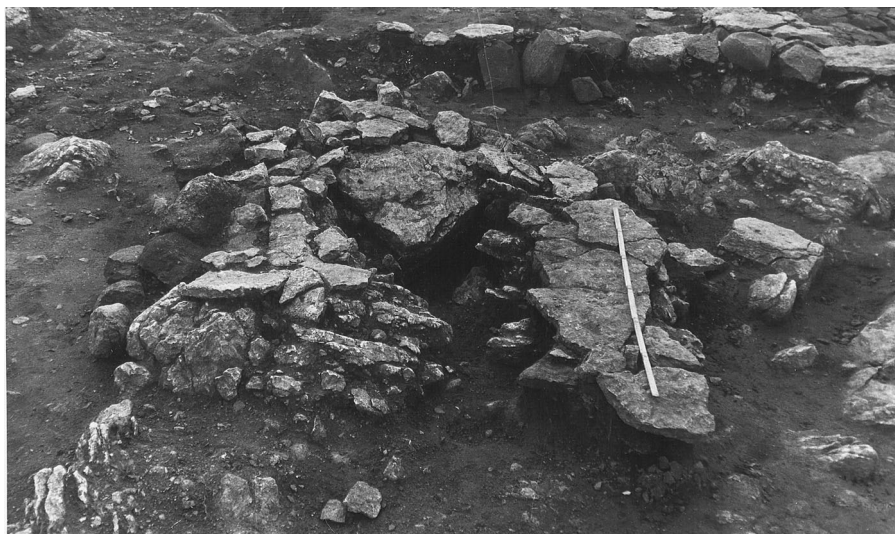
**Fig. 10.** Lehmja settlement. Remains of a stove in a house sill (L. 18). Some limestone slabs laid in the side and back walls of the stove have been preserved. The view is from the NNE side.

The **L. 18 House site** was actually recognized by the presence of stove remains. The latter were NNE–SSW oriented and measured 1.5 m in length and 1.4 m in width, with the mouth of the stove facing north (Fig. 9). The furnace dimensions measured 1 m in length and 50 cm in width. Some limestone fragments had been preserved at the stove base, probably originating from one or several larger hearth-stones. The walls of the stove had been constructed from quite substantial flag-stones 40–50 cm wide, the furnace sides of the slabs had acquired a slightly orange colouring from the heat. Also some quarry stones had been used for constructing the stove walls, as seems to be indicated by the head-sized granite stones that were found on the margins of the eastern wall line (Fig. 10).

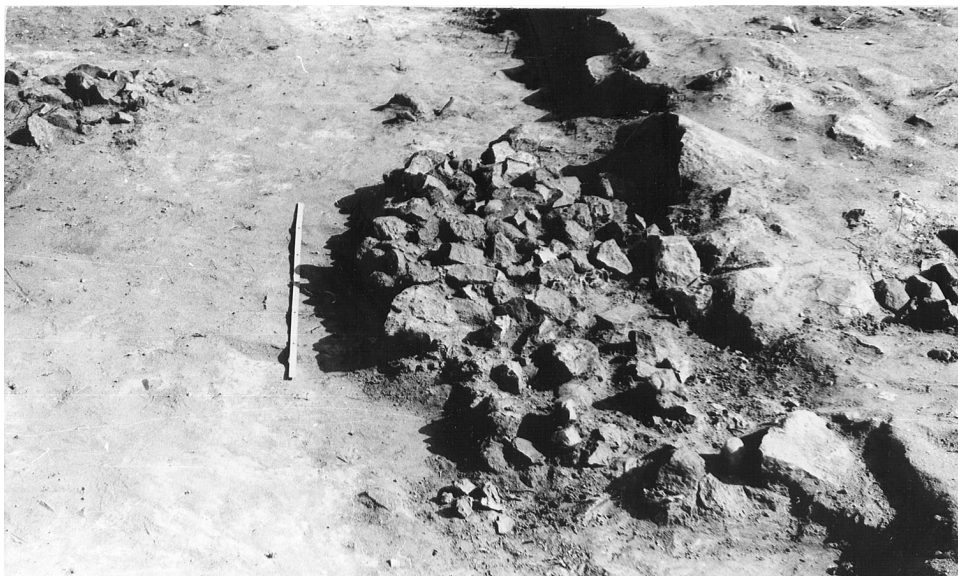
**Fig. 11.** Olustvere settlement, hearth No. 23. The base of the earthen stove has been laid from granite stones.

**O. II, Furnace No. 23** comprises a rectangular, 1.5 × 0.8 m heap of granite stones (8–12 cm in diameter) that have been disintegrated by heat (Fig. 11). Beside charcoal, a notable abundance of heat-treated clay fragments were found

The Olustvere fireplace No. 23 can be given as an example of a flueless stove. A 30 cm thick layer of earth was discovered from under the stove base, comprising a clearly discernible rectangular spot in the sandy ground. There seems to have been situated a timber frame that had been filled with a mixture of sand and soil. The stone base of the stove rested on the wooden frame and was covered by an earthen hood. It follows that the stove was not a typical earthen oven set on a wooden frame, but rather a combined heating device that had its base built of stone, while the hood was made of clay (Lavi 1997, 111).

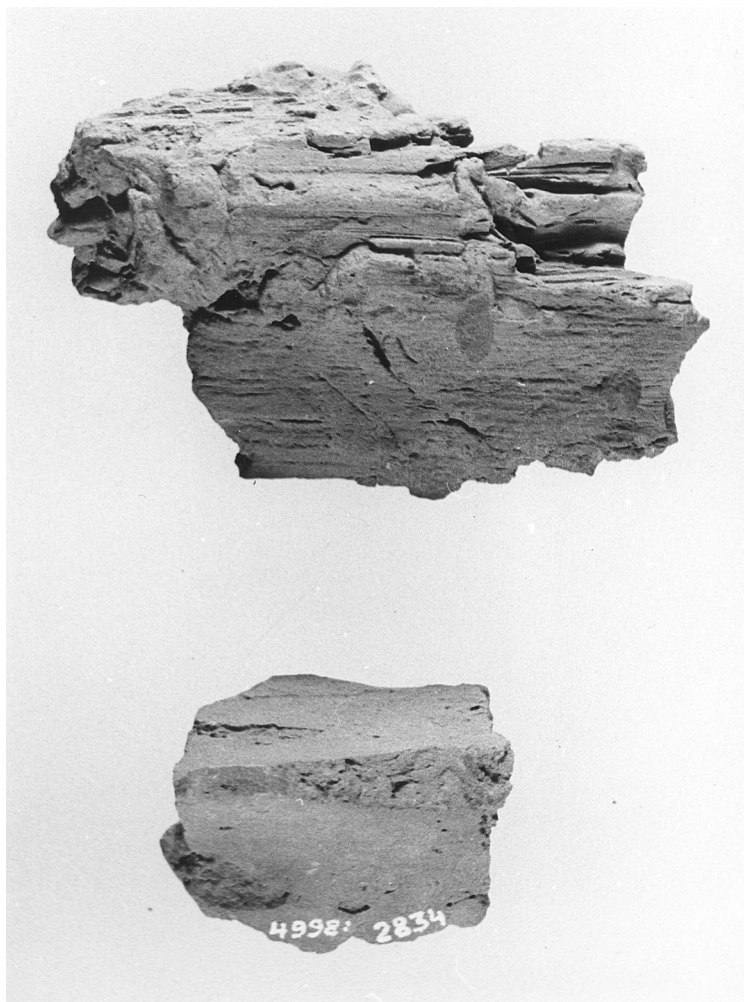
**Fig. 12.** Olustvere settlement. House sill (O. VII, 2); clay jointings, probably originating from a round-beam roof.

from a ceiling constructed of thinner round beams. It has been suggested that the ceiling beams had been covered by sand and moulded with clay from the downside, thus explaining also the pieces of clay jointing that have been found from the house site (Тыниссон 1987, 181). The explanation seems disputable, as it is not very likely that the clay jointings would stick to the lower sides of smoothed logs. It is much more likely that clay was used to caulk the gaps between the beams from the upside, which also kept the insulating sand layer from crumbling. Triangular jointing fragments have also been found from the house sites of Olustvere (O. VII, 2; 3); judging by the shape (Fig. 12), those pieces, too, should
